Willow Glen Town Square Case Study

Ambiguous Responsible Parties

City of San Jose – Environmental Services Department

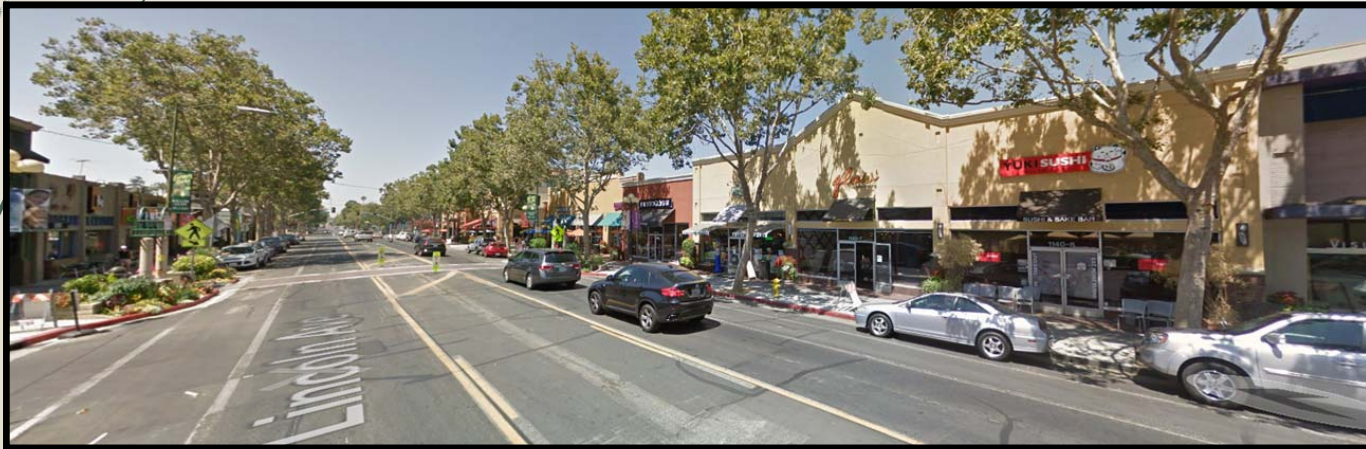
- ▶ Downtown Willow Glen - Lincoln Ave
- ▶ Combined Commercial / Residential zone
- ▶ Multi-tenant buildings
Restaurants, coffee/juice shops, retail stores, supermarkets, law offices, etc.
- ▶ Sidewalks, access roads, parking spaces

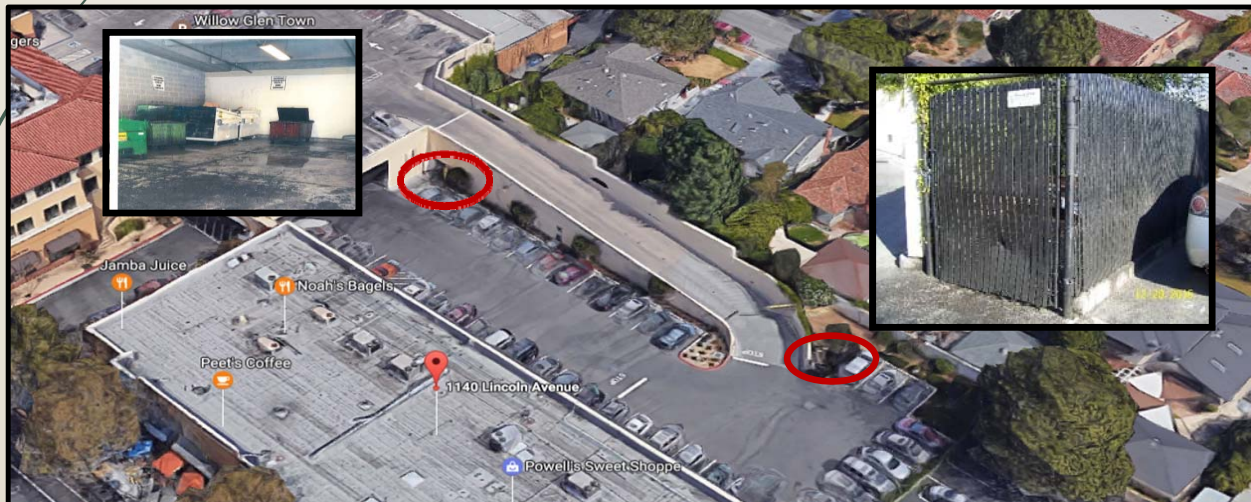
- ▶ Area of concern:
 - ▶ Parking lots - back of the buildings
 - ▶ Open tallow enclosure spot (chain link fenced zone)
Used by 5 food places produce oil/ grease
Managed by Property Manager
Six parties involved
 - ▶ Indoor/ locked dumpster areas for trash only

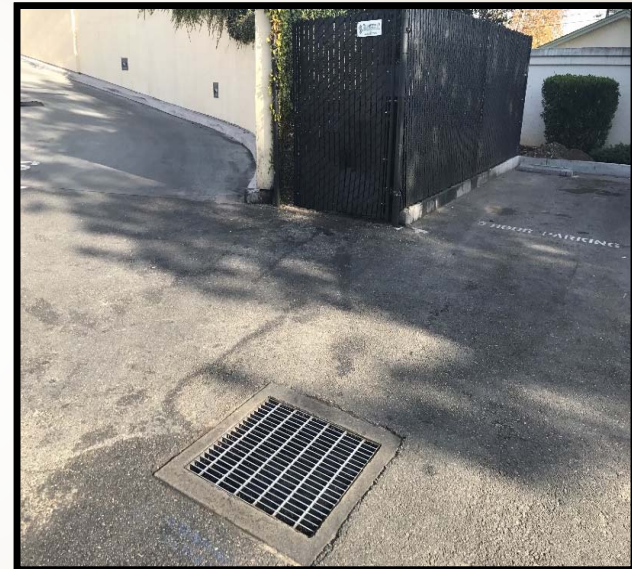
Site Description

- ▶ Enclosure Area/ Nearby Drains:
 - ▶ Parking lot – a few feet away from the enclosure
 - ▶ Enclosure area (plugged drain)
 - ▶ Behind enclosure on the planting area

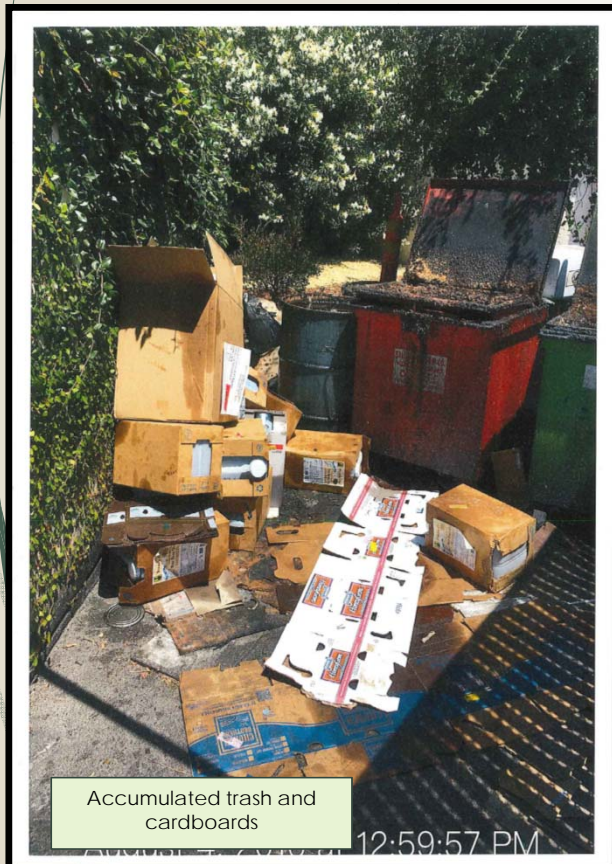
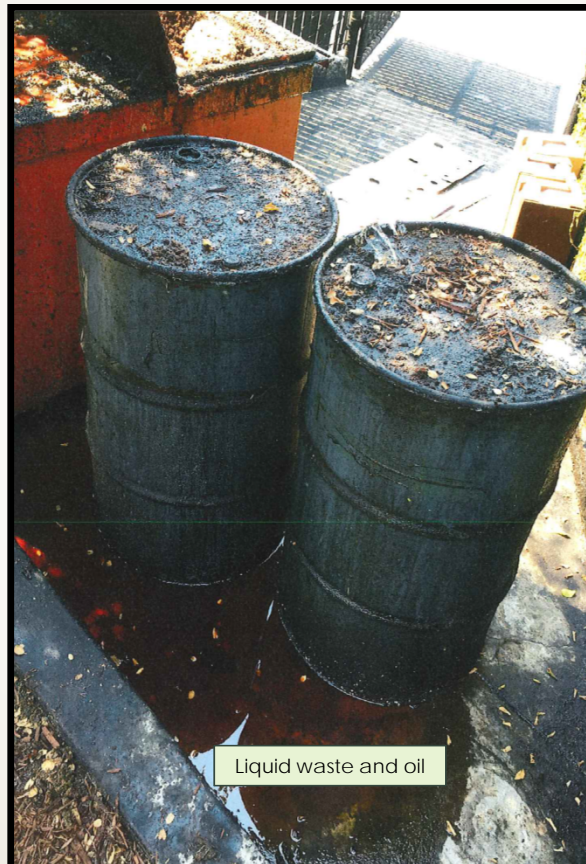
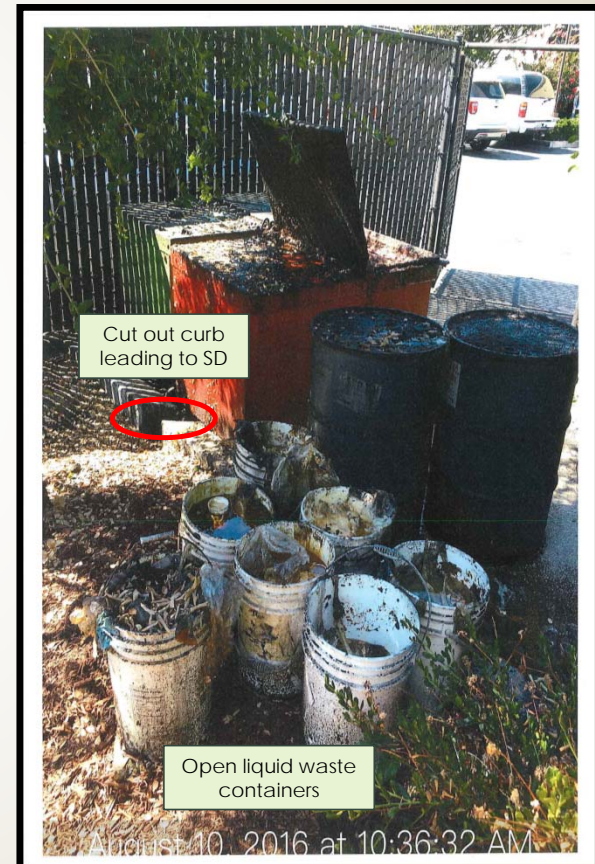
History (IDDE Inspections)

- ▶ IDDE & FOG Violations
- ▶ Last IDDE case: 08/2016 – 10/2016
 - ▶ Storm drains: Debris, cigarette butts, other pollutants
 - ▶ Enclosure area: Greasy tallow bins/ open buckets of cooking oil/ cardboards/ trash
 - ▶ Outside of tallow zone/ Parking lot: Greasy/ traces of fresh oil
 - ▶ Health issues: Rodent and insects (cockroach) infestation
- ▶ IND: Industrial/ commercial (inspections)
- ▶ IDDE: Illicit Discharge Detection and Elimination (inspections)
- ▶ FOG: Fat Oil and Grease (inspections)

- ▶ IDDE inspector conducted inspections
- ▶ Unresponsive Property Manager
- ▶ No Remedial actions (about two months)
- ▶ Issued multiple violations/ citations
- ▶ Results:
 - ▶ Cleaned parking lot/ storm drains/ enclosure area
 - ▶ Fixed the curb (cut out curb leading to a storm drain)
- ▶ IDDE: Illicit Discharge Detection and Elimination

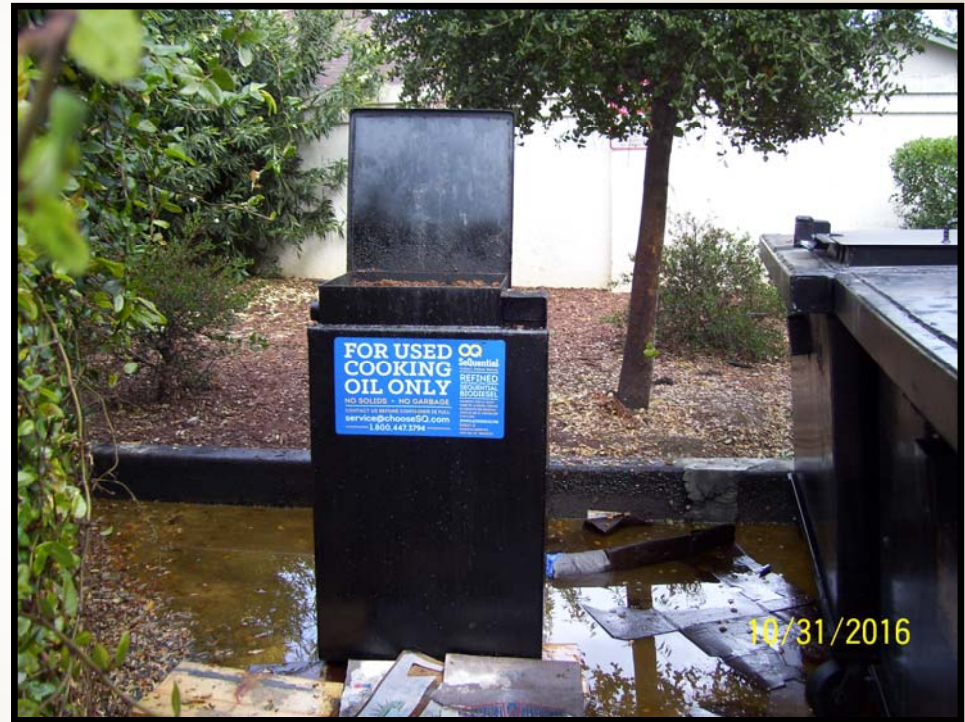
IND Inspections - Findings

- ▶ Enclosure area
 - ▶ Enclosure walls
 - ▶ Two tallow bins
-
- ▶ IND: Industrial / Commercial (Inspections)
 - ▶ IDDE: Illicit Discharge Detection and Elimination (inspections)

- Issued Referral to Administrative Citation (ACR)
 - RP: Property Owner
 - No direct discharge to the storm drain system
- Responsibilities:
 - Restaurants: Tallow bins
 - Property Manager: Enclosure area/parking lot/ storm drains
- Dry methods only
- Effective methods to prevent violations in the future
 - Move tallow bins to the trash area (indoors/ locked)
- No remedial actions for three weeks
 - Conducted Follow up inspections
 - Issued multiple citations
- ACR: Escalate enforcement action to evaluate the citation
- IND: Industrial/ Commercial (inspections)
- RP: Responsible Party

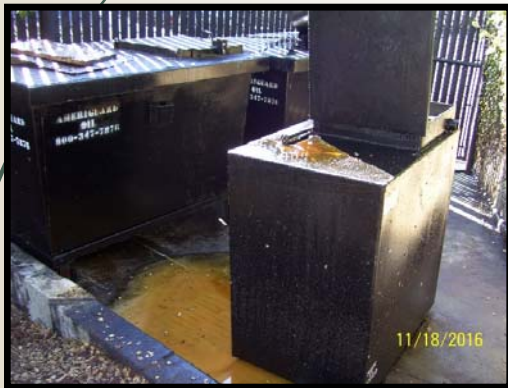
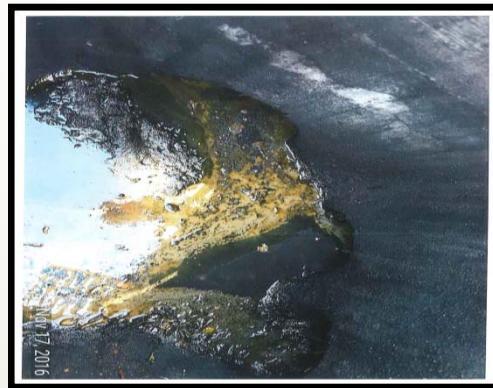
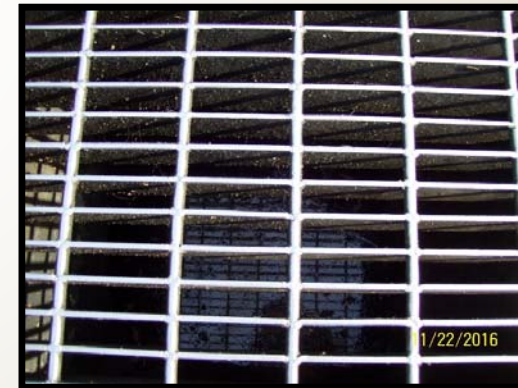
New Violations

- Complaint about a **power washing** tallow bins/ enclosure area/ parking lot
- IDDE inspectors opened a new case (direct discharge to the SD system/ complaint-based)
- Signs of power washing/ grease in the drain/ splattered grease on parking lot surface
This storm-drain flows downstream through a media-filter

- ▶ Issued Administrative Citations to both companies
 - ▶ Property Manager & Contractor
- ▶ Suspected that grease had impacted the media filter (C.3)
- ▶ Required inspections and service of media filters/ clean up the storm lines

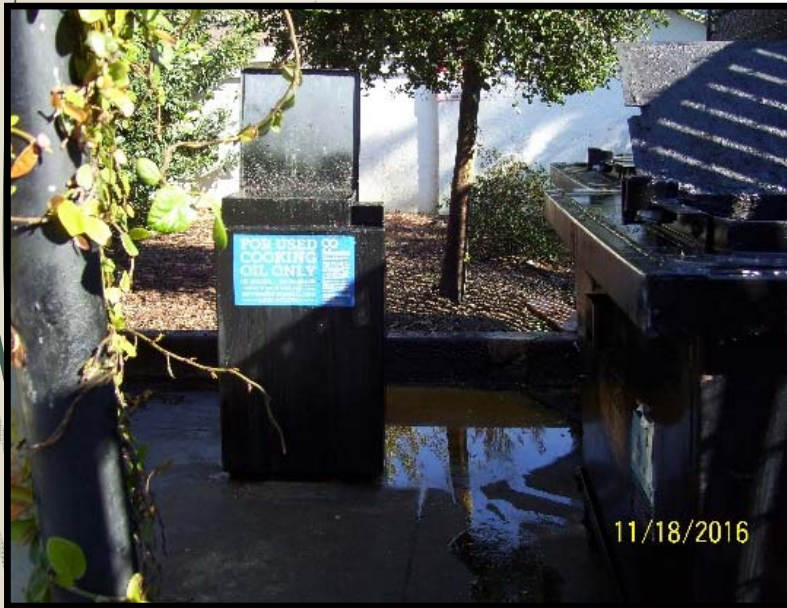
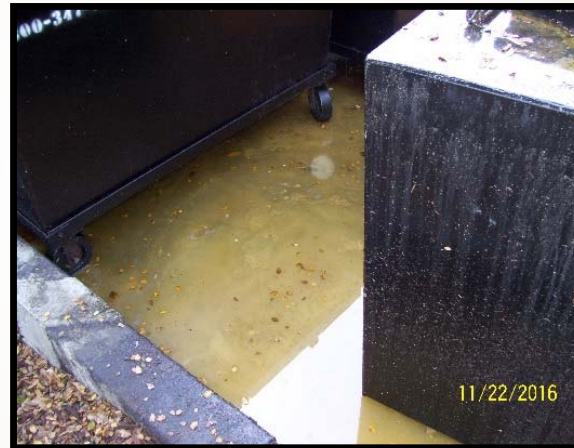
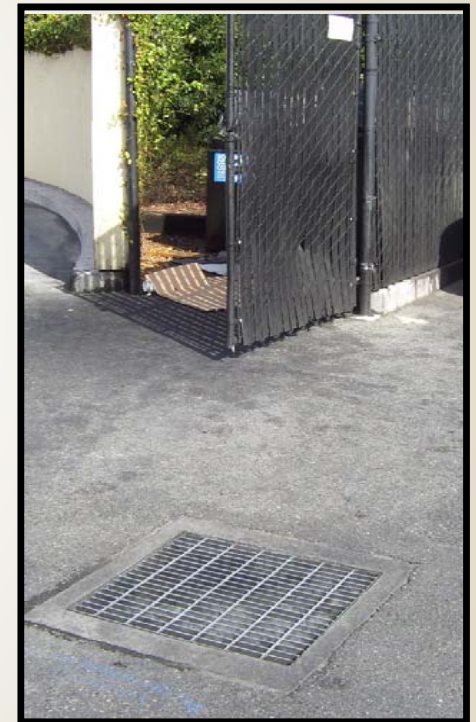
IND Follow up Inspections

- ▶ Continued IND Inspections: Yearly basis inspections/ classification based
- ▶ Required clean up of oil and grease from:
 - ▶ Tallow bins (lids and sides)
 - ▶ Enclosure area
 - ▶ Affected parking lot
 - ▶ Storm Drain catch basin
- ▶ IND: Industrial/ commercial (inspections)

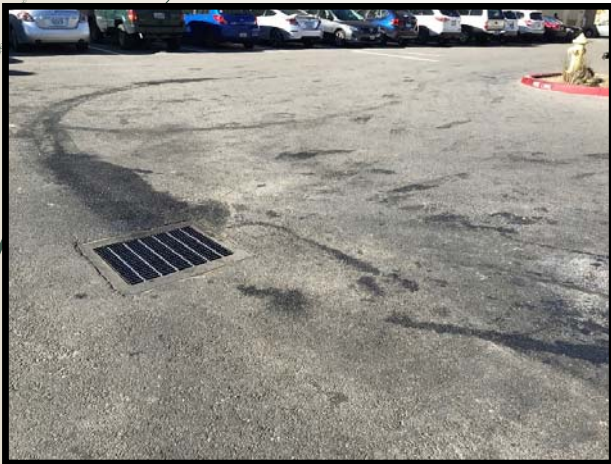
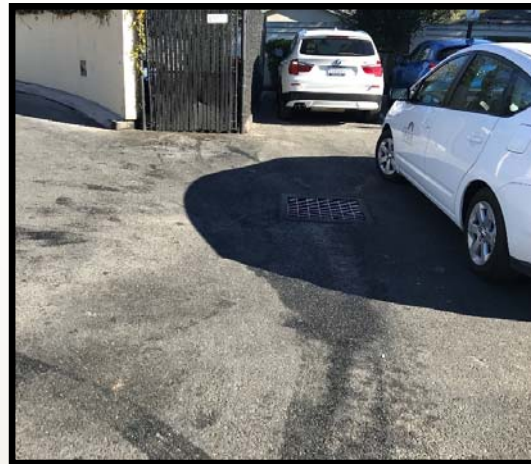
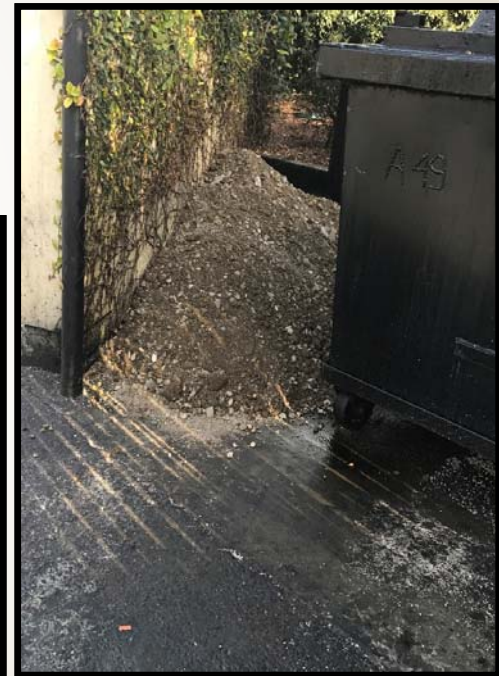
IND Follow up Inspections

- ▶ Dealing with an unresponsive Responsible Party
 - ▶ Discussions over phone calls and emails
 - ▶ Mailed and emailed copies of reports, citations, and recommendations
- ▶ New violations:
 - ▶ Trace of oil and grease on parking lot
 - ▶ Piles of uncovered soil and construction debris

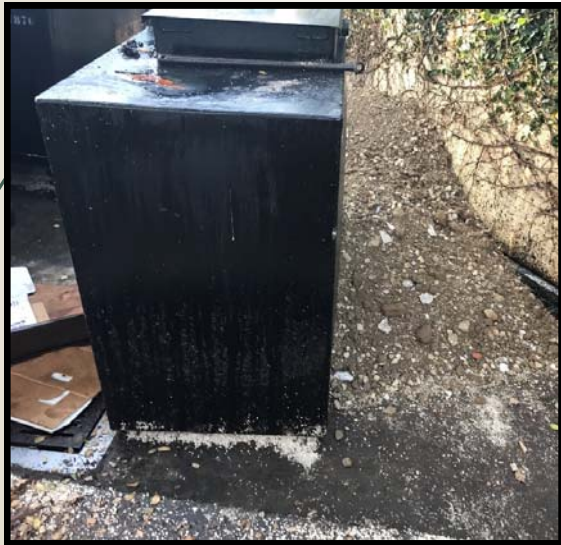
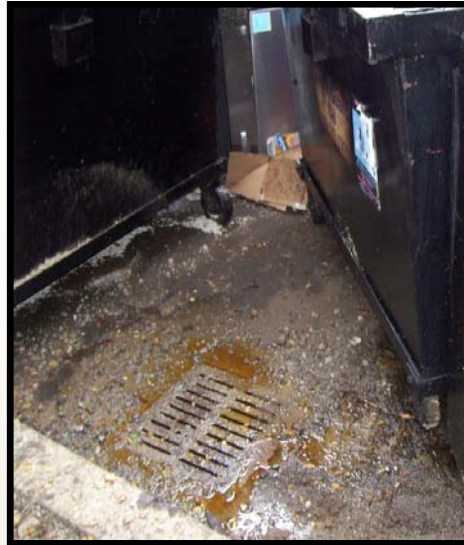
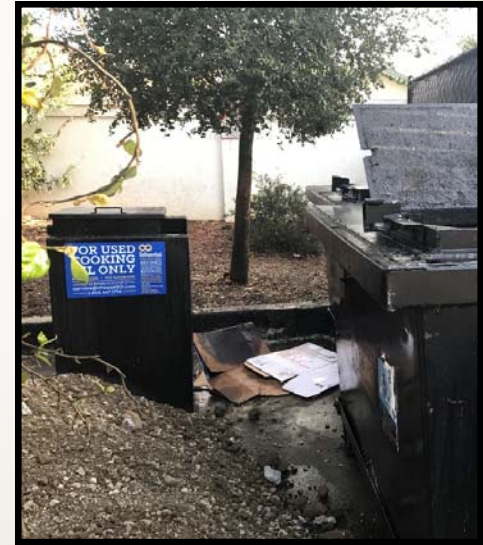
► Dirty Job/ Beautiful Result

- Restaurants agreed on the indoor tallow bins
 - Individually Responsible
- PM removed the bins and cleaned the area
 - Code Enforcement
