Case Scenario

Supermarket – Food Service Establishment (FSE)

Joshua Villa
Environmental Inspector
Watershed Enforcement
May 20, 2015

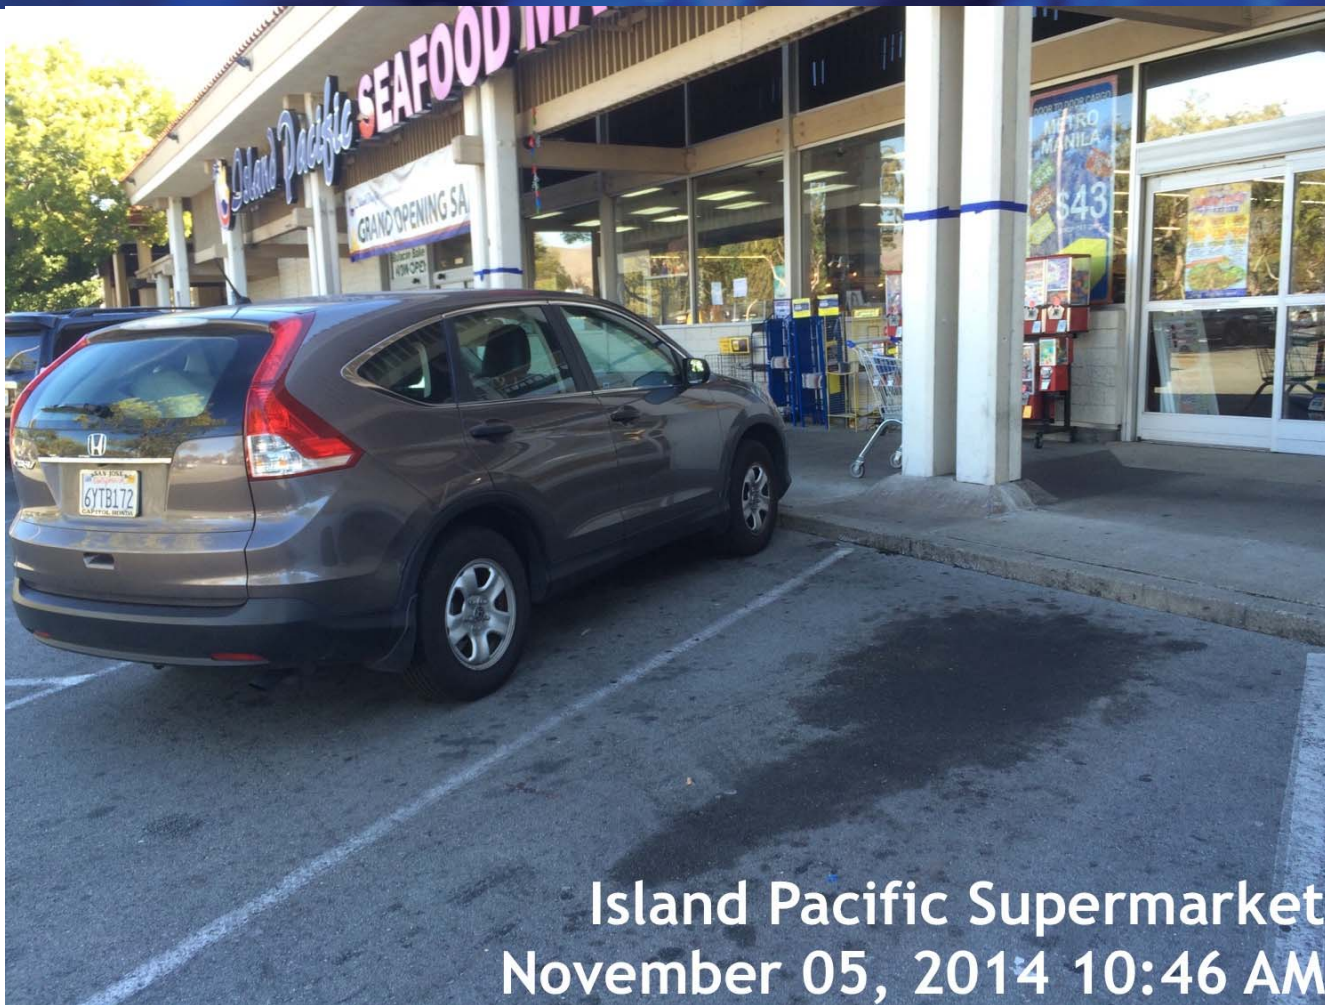
Island Pacific Supermarket
November 05, 2014 10:46 AM

This is a locally owned supermarket and FSE

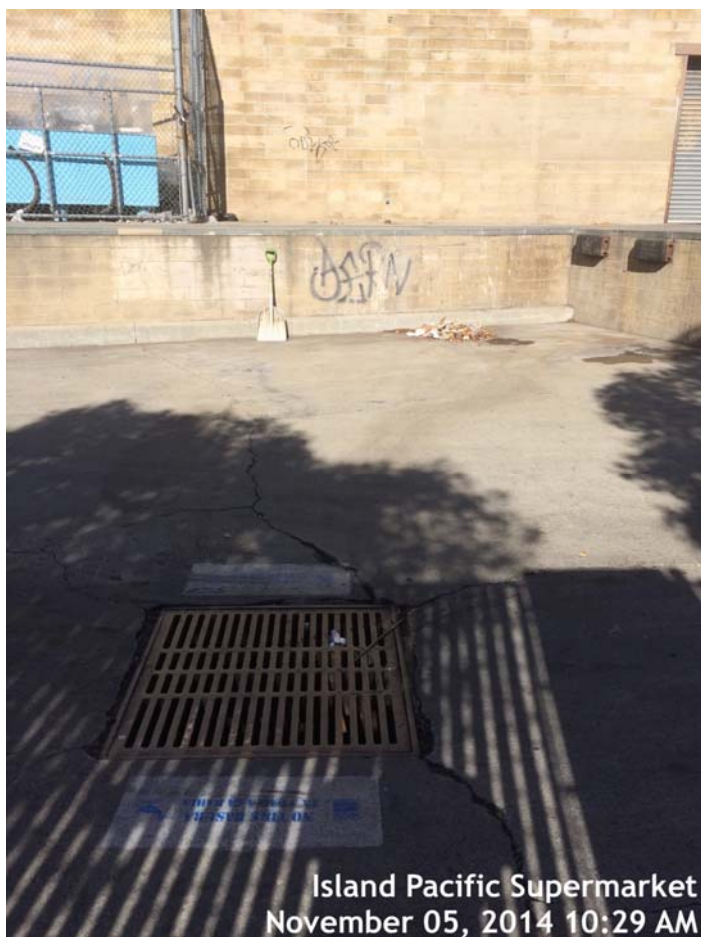
Island Pacific Supermarket
November 05, 2014 10:29 AM

Initial Inspection

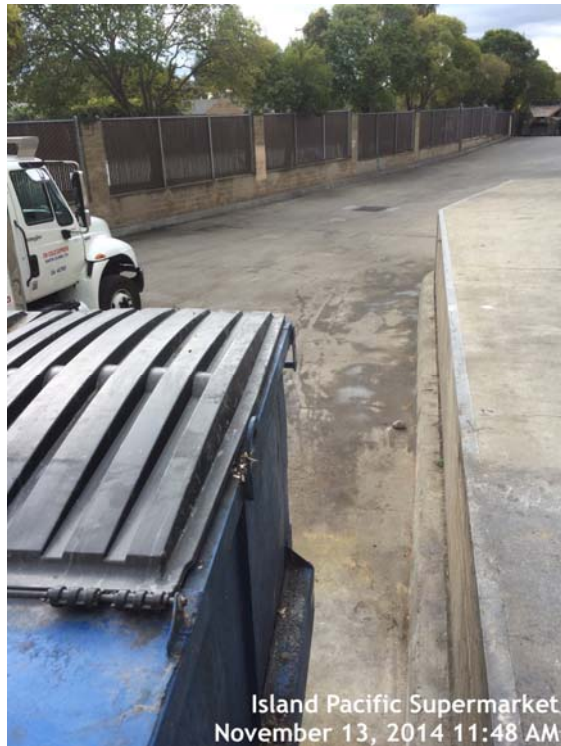
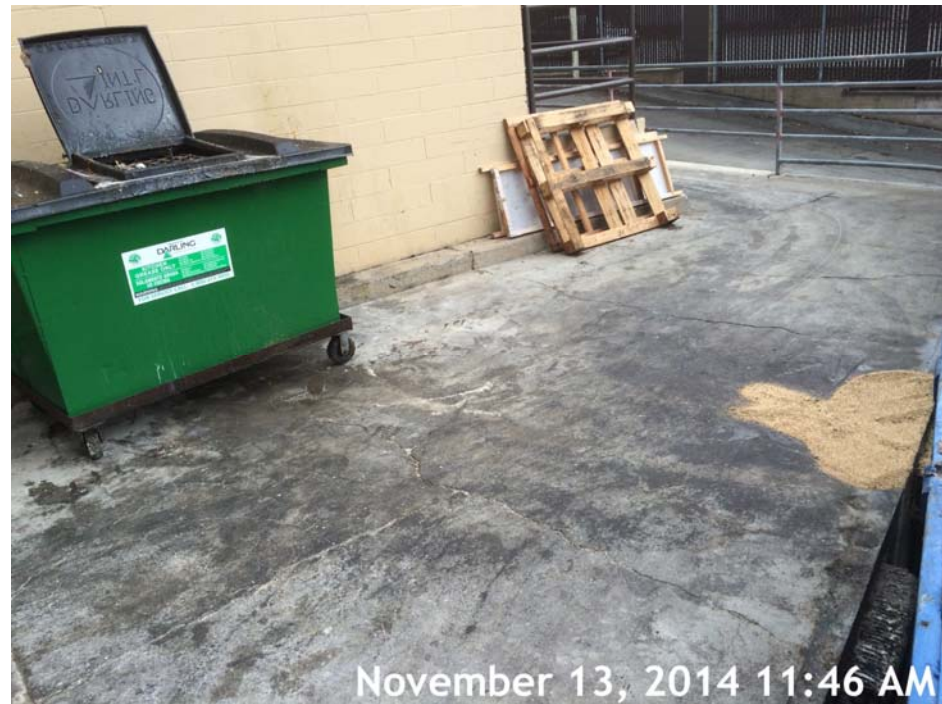
Upon the follow up, tallow bin grease and left over absorbent is on the move, and leaky bins are still on site...

Supermarket management and staff were trained on storm water pollution prevention practices, proper spill clean up techniques, and storage options for the tallow bin.

- Garbage can/compactor/dumpsters/recycle bins/scrap bin/tallow bin
 - Repair
 - Clean up using dry method and properly dispose of spills, discharges, tracked sediment, leaks, stains, process residues, and debris.
- Parking Lot/yard
 - Clean up using dry method and properly dispose of spills, discharges, tracked sediment, leaks, stains, process residues, and debris.

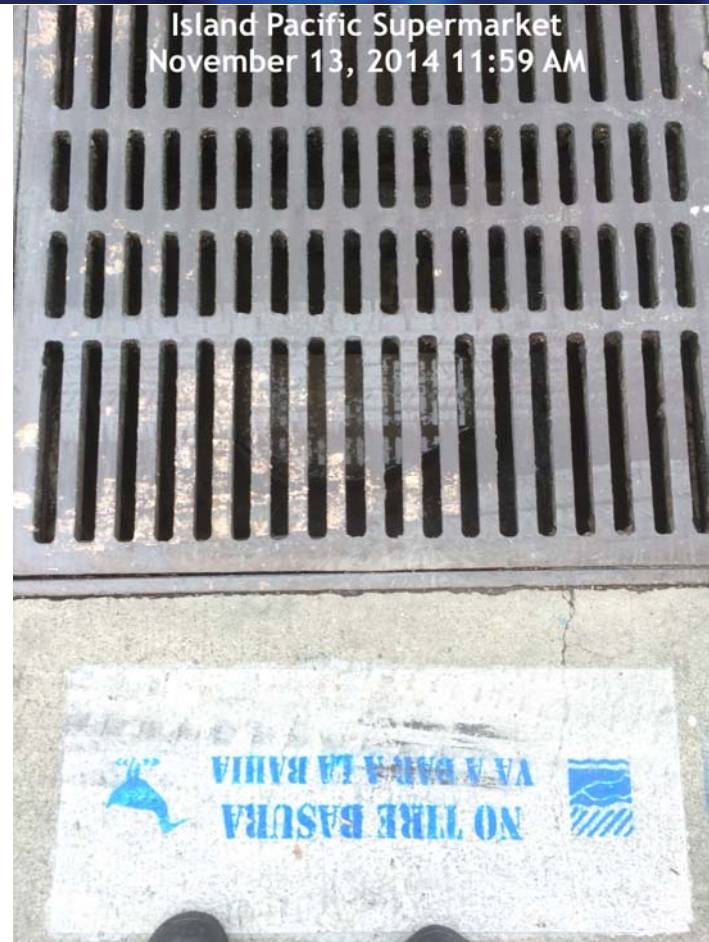
Discharge from activities in their loading dock may easily flow to the nearby stenciled catch basin...

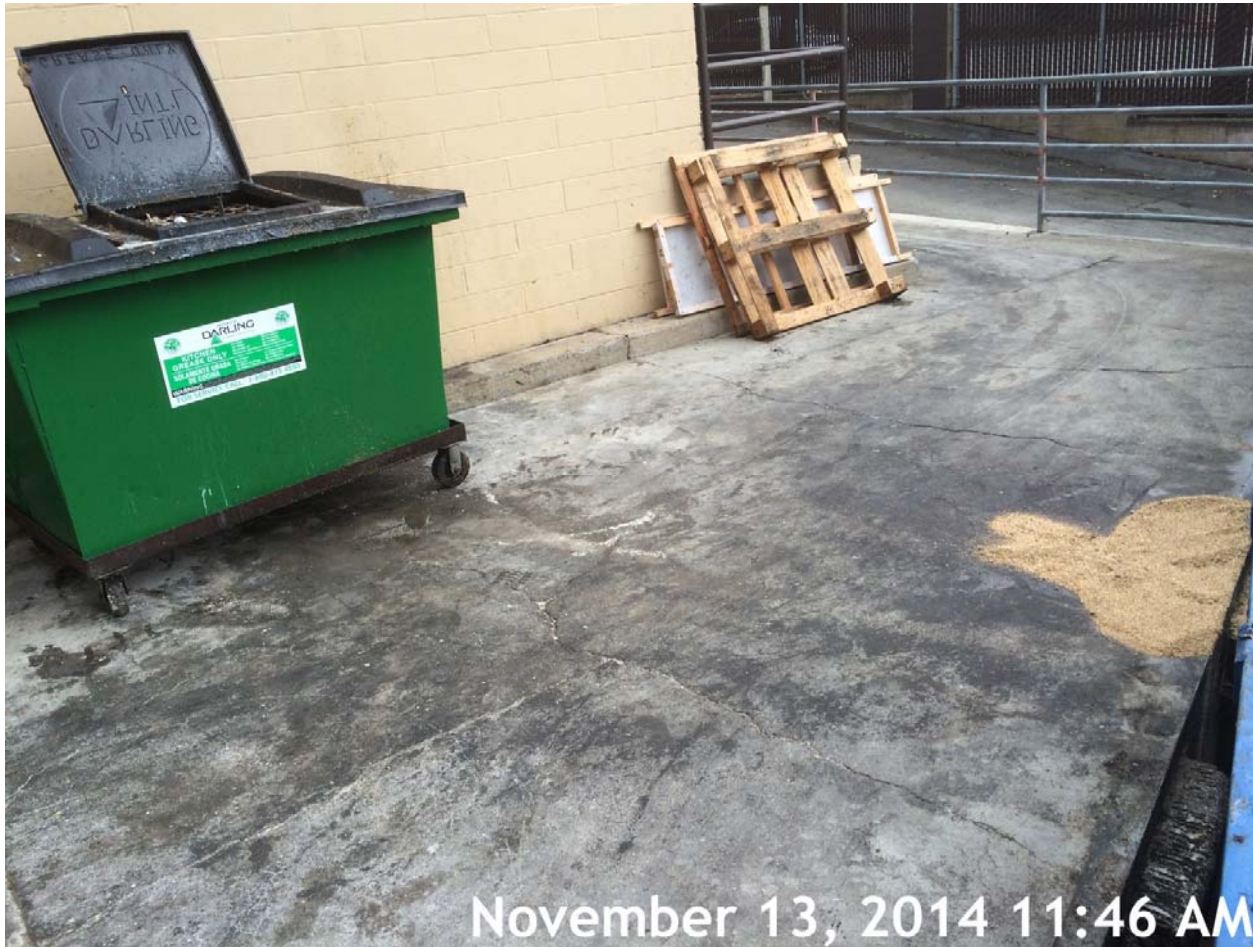
Outdoor tallow bin storage, greasy spills, and absorbent...

- Parking lot oil spills were cleaned up using dry methods and properly disposed of.
 - Leaky trash bin was replaced.
 - Tallow bin grease spills were cleaned up using dry methods and disposed of properly.
 - Tallow bin was moved inside of the building.
- *No pictures were taken of the final follow-up inspection

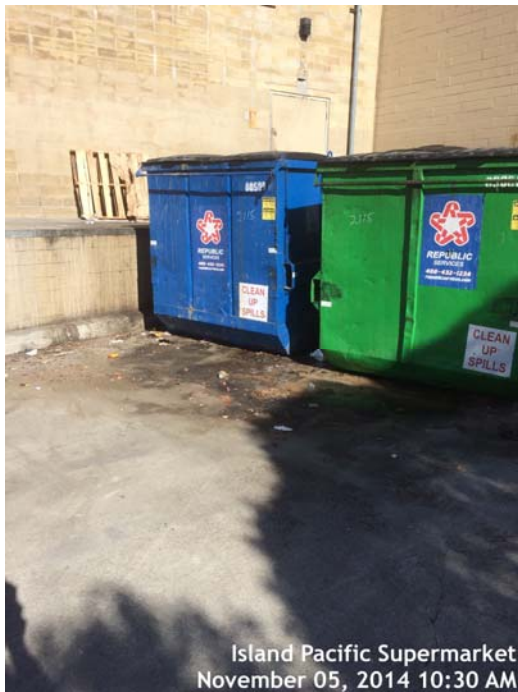
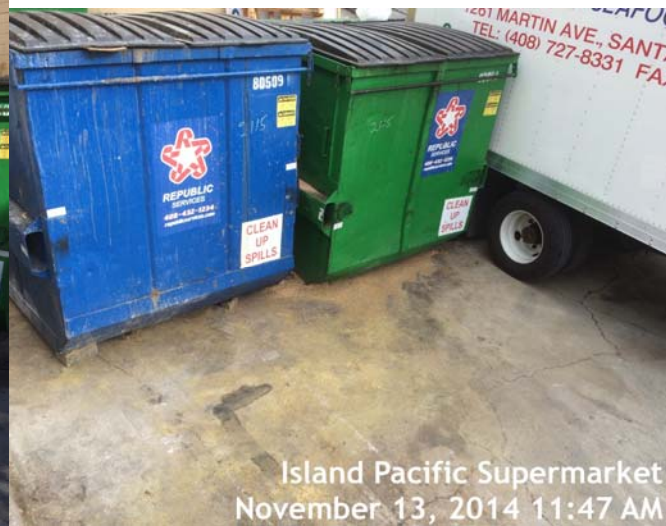
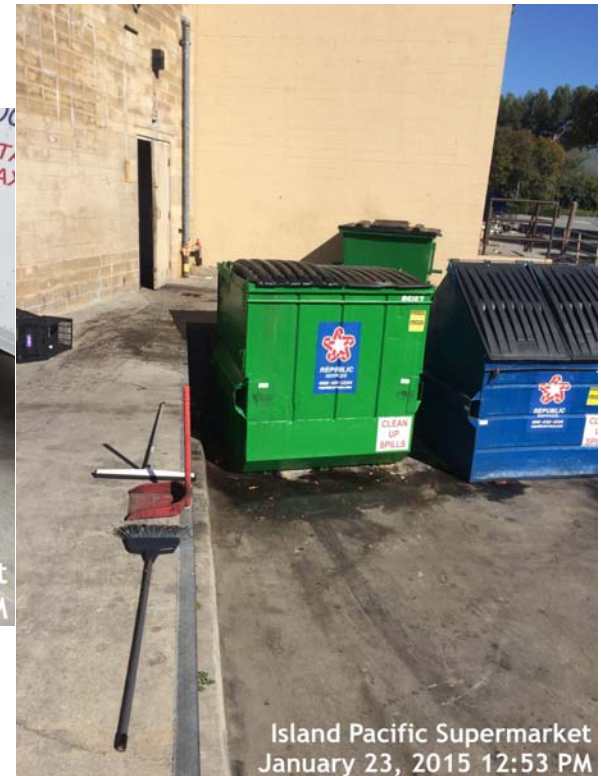
Three inspections with the same reoccurring issue...

An Official Warning Notice was issued for the parking lot violation and three Referrals for Administrative Citation were issued.
