CITY OF
PALO ALTO

CASE SCENARIO

Forklift Service Facility

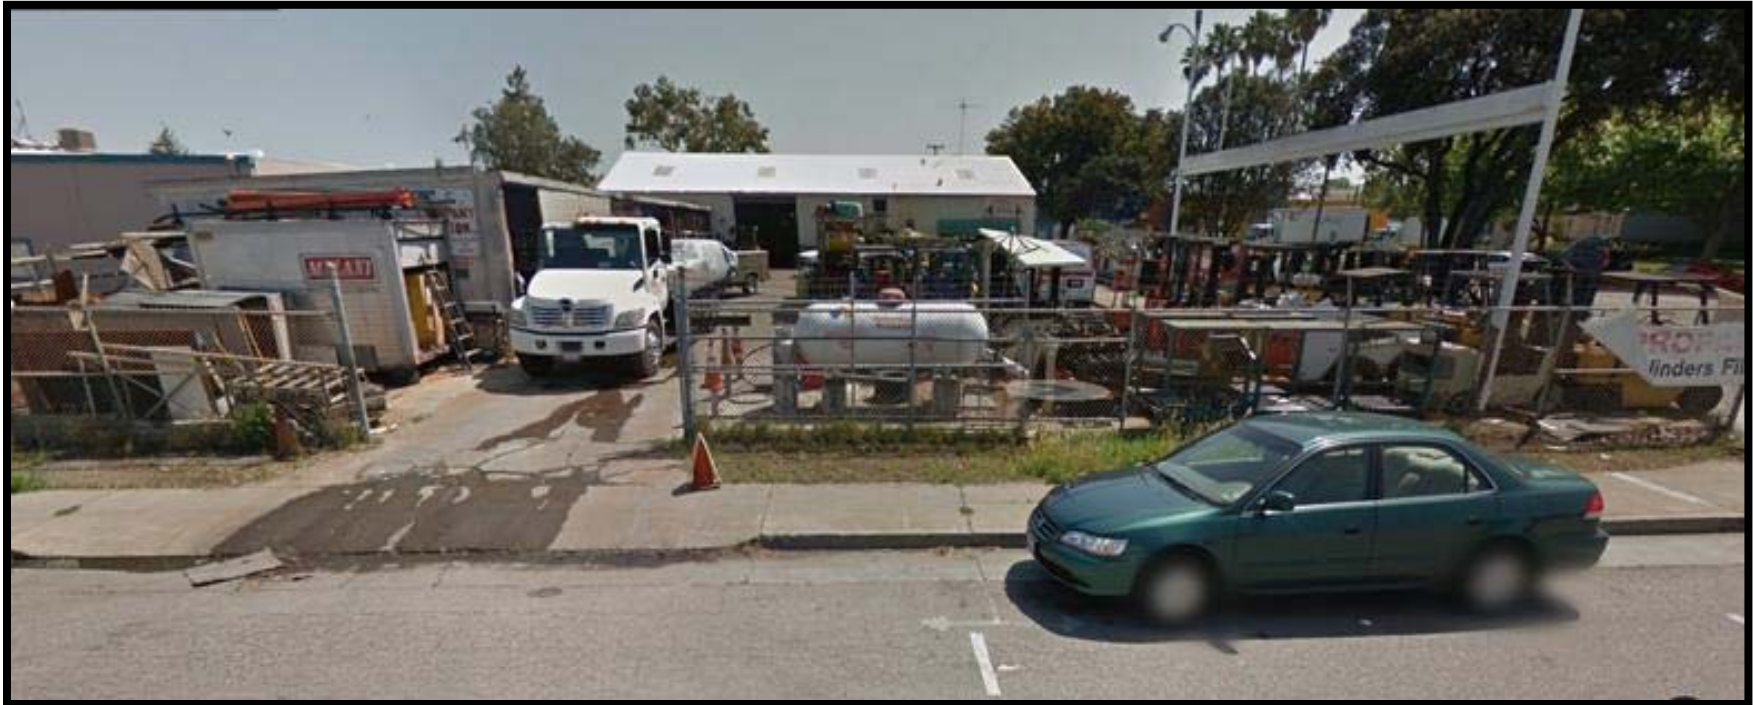
There appears to be water seeping through the pavement and running offsite to the street.

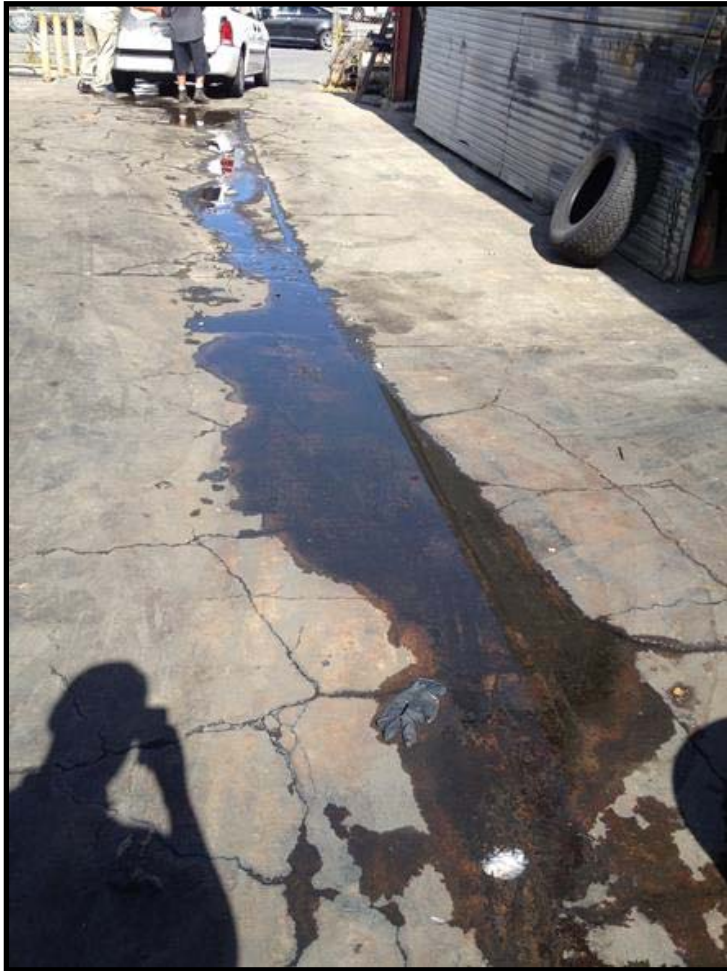
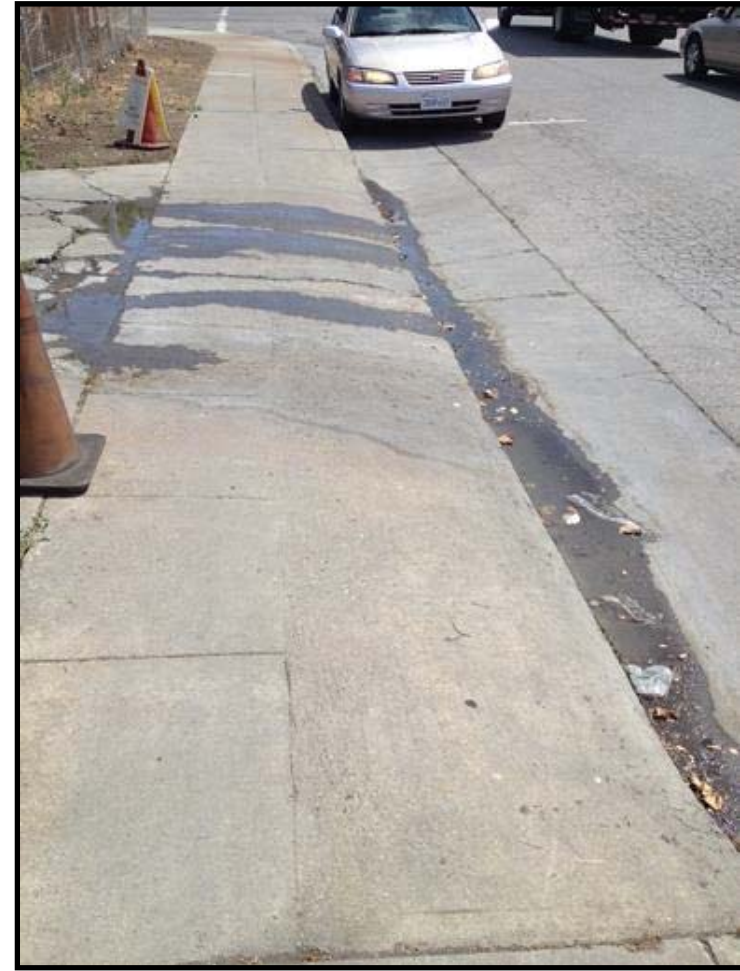
Forklift steam cleaning and maintenance is being performed outdoors with no implementation of BMPs.

Facility personnel were trained on applicable BMPs. The Steam cleaning pad was moved indoors, sealed, and berms were constructed to eliminate run-off and overspray to the storm drain system.

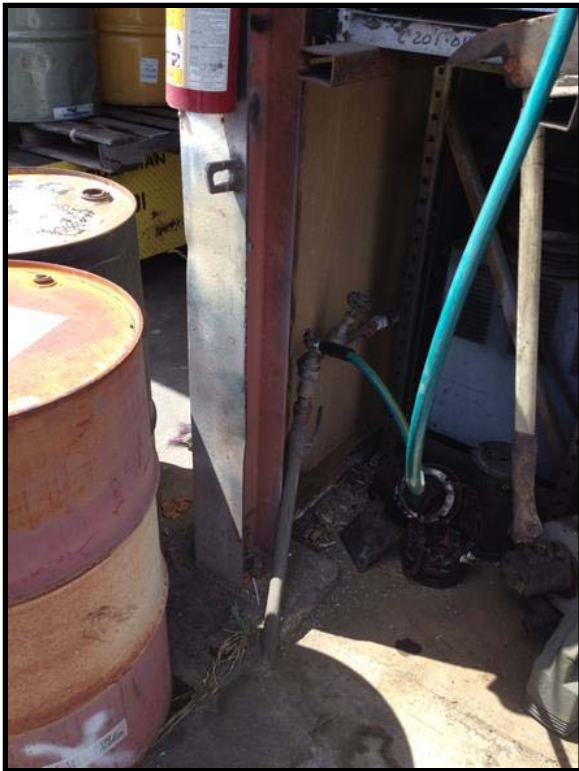
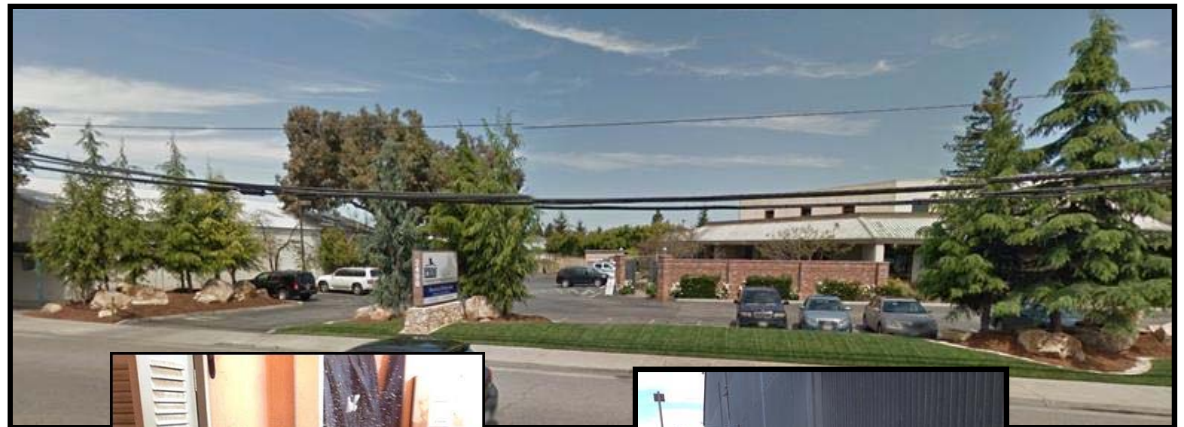
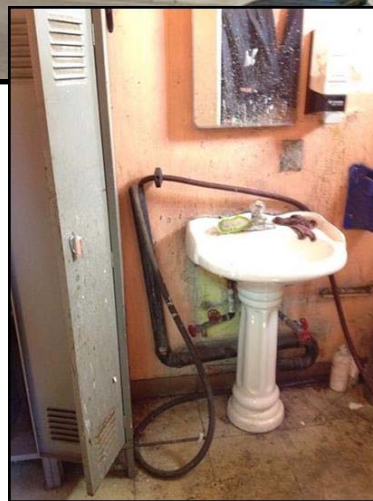
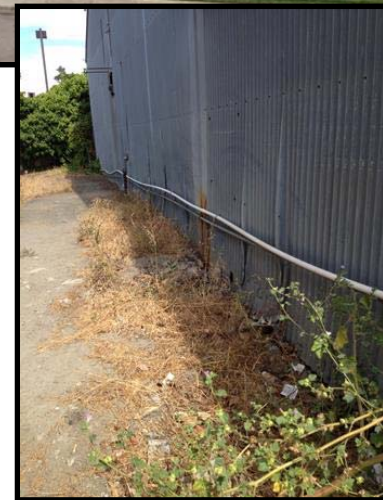
After further investigation, you become aware that the source of the water running off-site is likely a leaking unregistered Artesian groundwater well (Well). The Facility has plumbed this Well to the sanitary sewer to relieve the water pressure, so that less water seeps through the pavement. In addition, the Well is plumbed to a neighboring property for irrigation.
